Energy in Buildings and
Communities Programme

INSPIRATION AND EXPERIENCES FROM THE JOINT ANALYSIS OF SHINING EXAMPLES OF COMPREHENSIVE ENERGY RENOVATION BUILDING PROJECTS WITHIN IEA EBC ANNEX 56

Ca'S. Orsola, Treviso, Italy

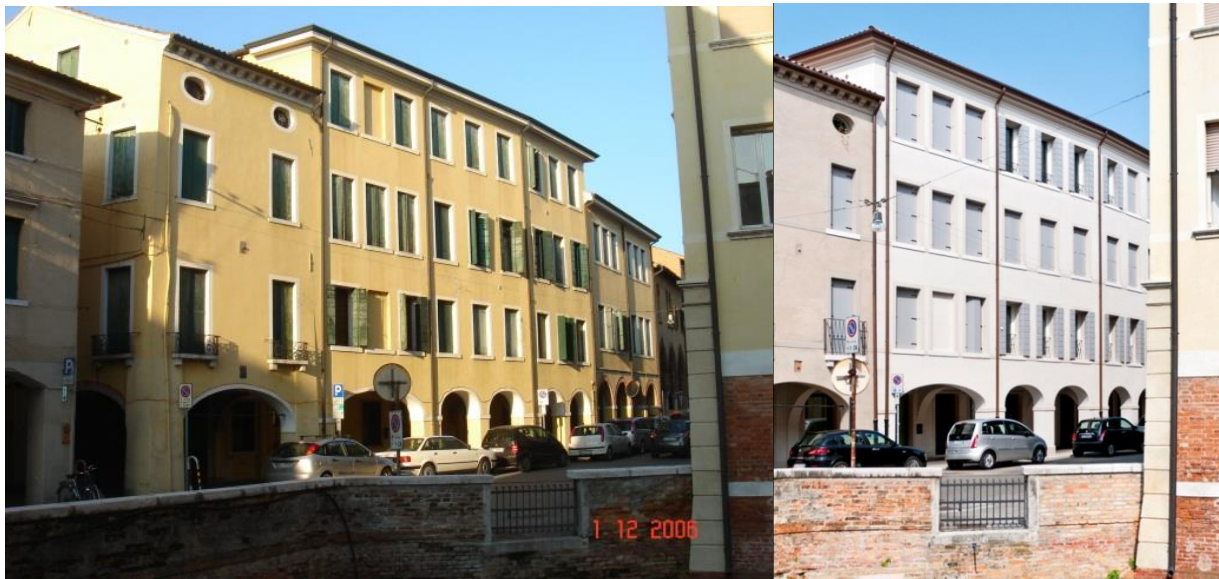
General view of the building before and after the intervention

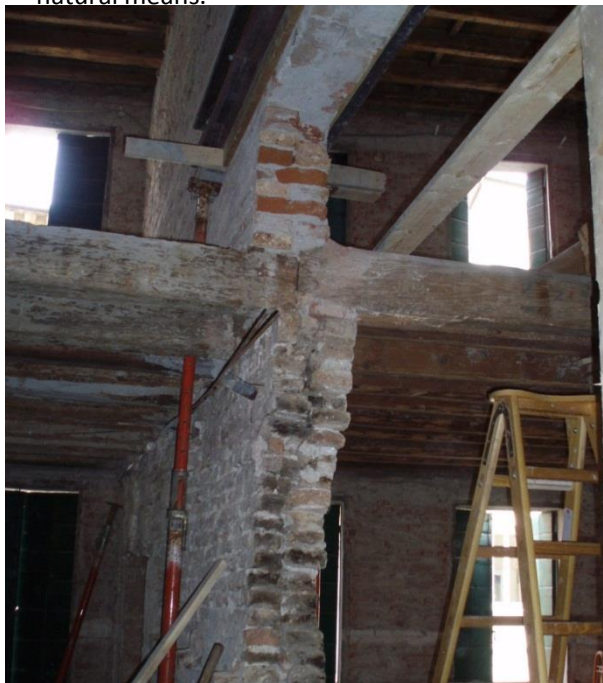
Crooked walls, before renovation

Originally it was a convent and it was inhabited until 2000 and during the time it kept intact the original structure and architectural distribution. Then it was bought in 2007 for acting a deeply renovation and converting it in a prestigious residential building. At the beginning of construction phase the structure revealed a quite ruined state of conservation: walls are crooked and presented different solutions, moisture affected wooden elements in the floors and in the roof.

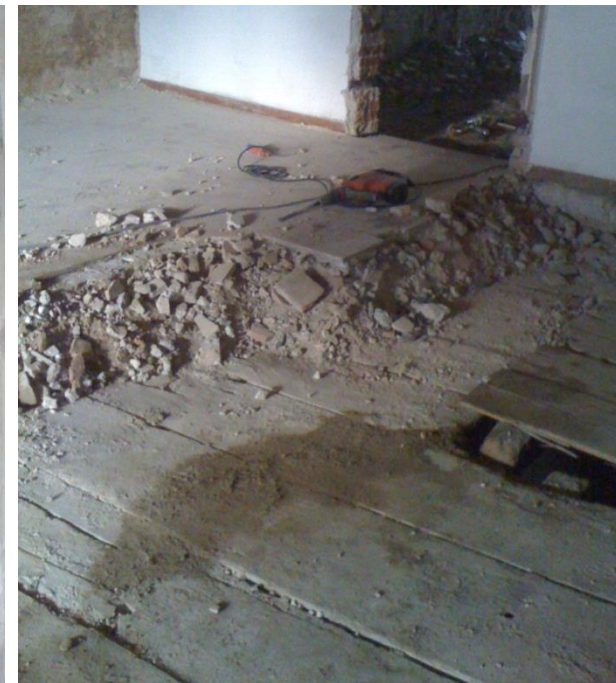
Demolished partition walls left and used as a substrate

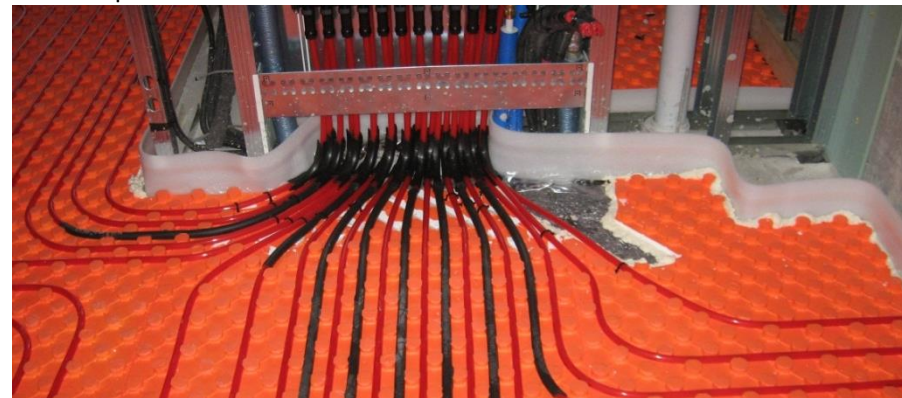
Radiant system

The HVAC generation system is a water to water centralized heat pump/chiller. The underlying well is the hot/cold water source and internal comfort is achieved exploiting a radiant system installed in the floor together with a dehumidification system for the summer period.

- Heating and Cooling: 32 kW heat pump and distribution with radiant floor system;
- DHW: 20 kW heat pump;
- Ventilation: mechanical ventilation system with heat recovery box with 95% efficiency.

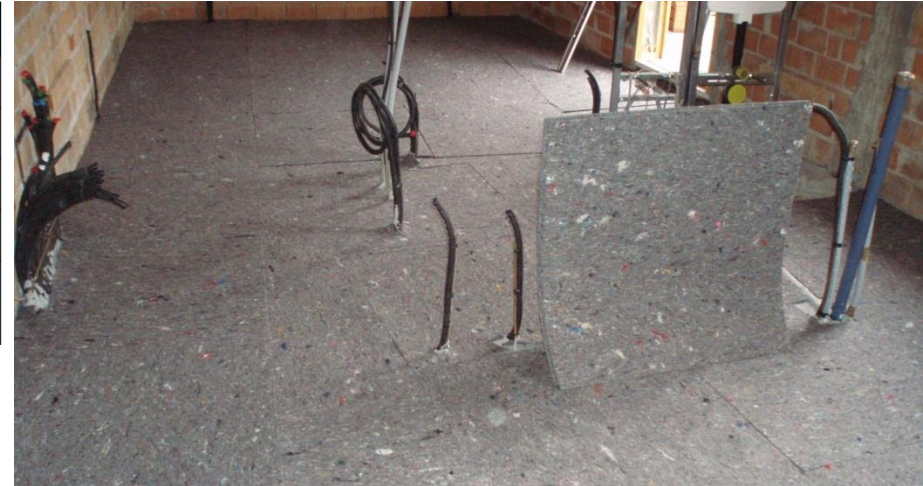
Photovoltaic system - TNT underflooring above systems

- Thermal solar panels for DHW production (20 m²) installed in vertical;
- Photovoltaic power plant producing 3230 kWh of total annual energy. The panels are installed on the roof and oriented to the south.

PV energy contribution: 3680 kWh a

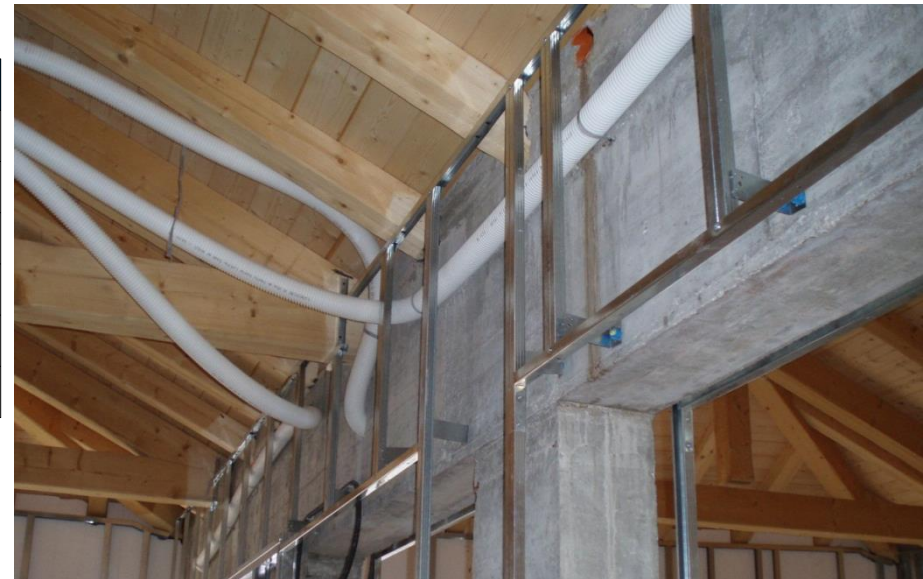
Mechanical ventilation system
