Housing typology Assessment

MORE-CONNECT WP3.1, June 2016, J.A.W.H. van Oorschot, MSc., ed.

HOUSING TYPOLOGY ASSESSMENT
MORE-CONNECT WP3.1

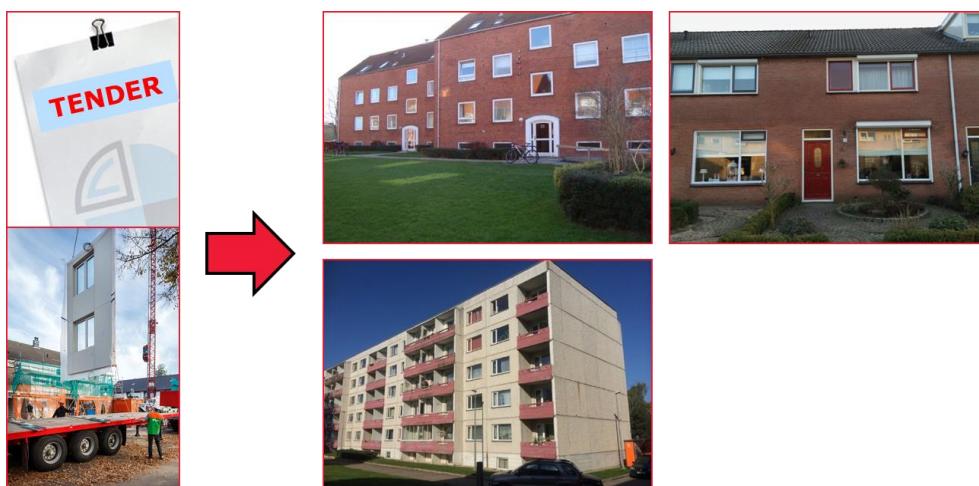
Figure 2.1: Conceptual idea of the housing assessment format: property will be assessed like the MORE-CONNECT contractor / provider would do in case of a tender.

Figure 2.1 presents the conceptual idea behind the detailed assessment: property will be assessed like the MORE-CONNECT contractor / provider would do in case of a tender. When deciding upon a nZEB retrofit approach for a specific residential building, it has first to be decided which alternative solutions to select from. Moreover, it needs to be decided if the modular MORE-CONNECT concept could provide a (cost-effective) solution from a product-market combination point of view. Table 2.1 includes the parameters which need to be assessed.

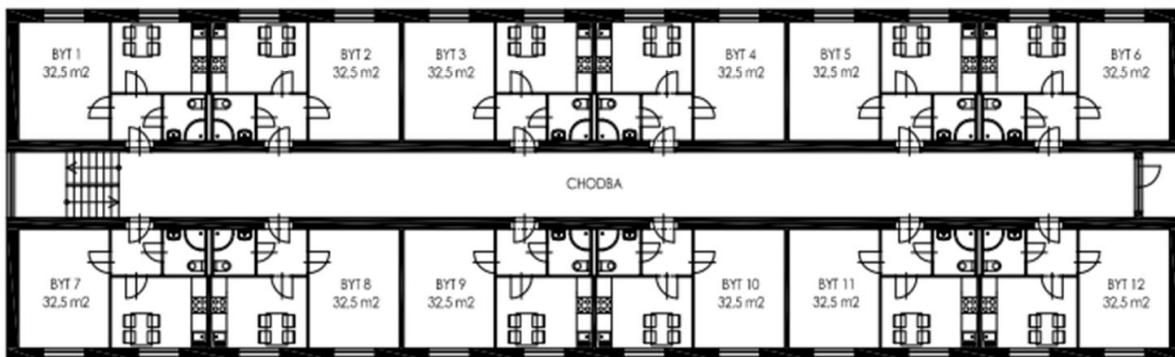
Figure 3.3: Floor plan pilot building

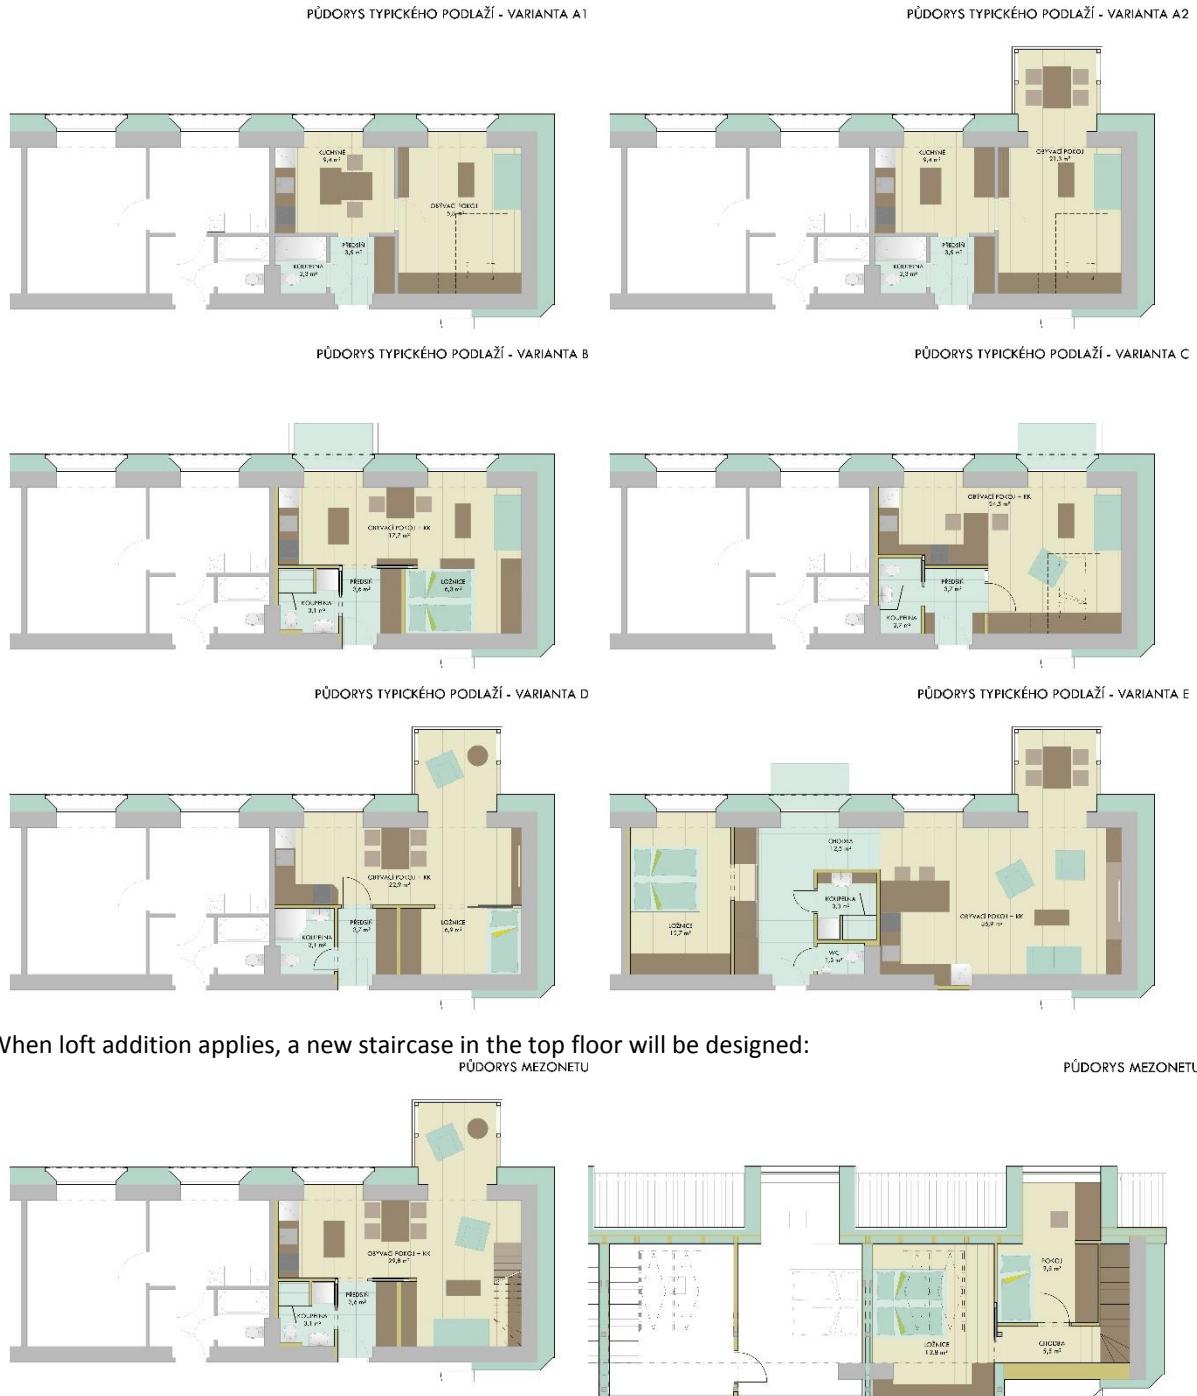
Figure 3.4a: Floor plan pilot building after renovation

No significant changes necessary in typical floor plan. Possible disposition changes can be following:

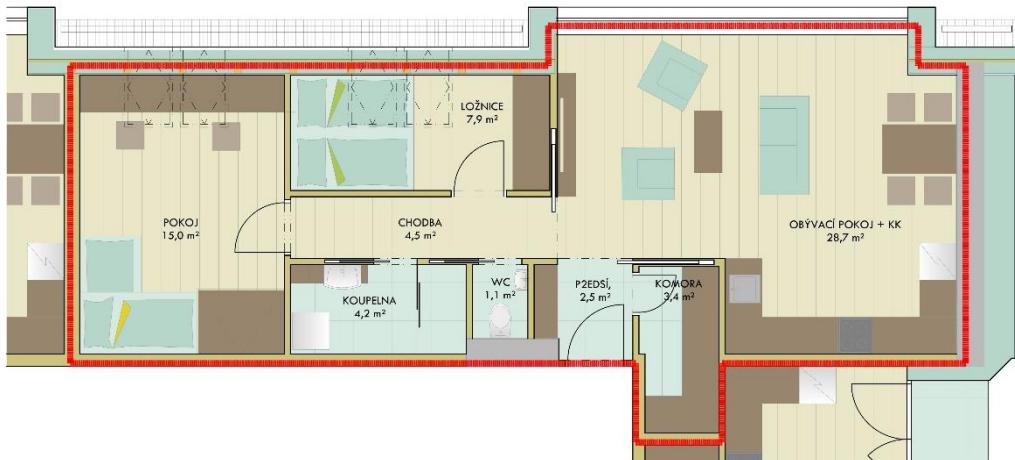
When loft addition applies, a new staircase in the top floor will be designed:

Figure 3.4b: Floor plan pilot building after renovation

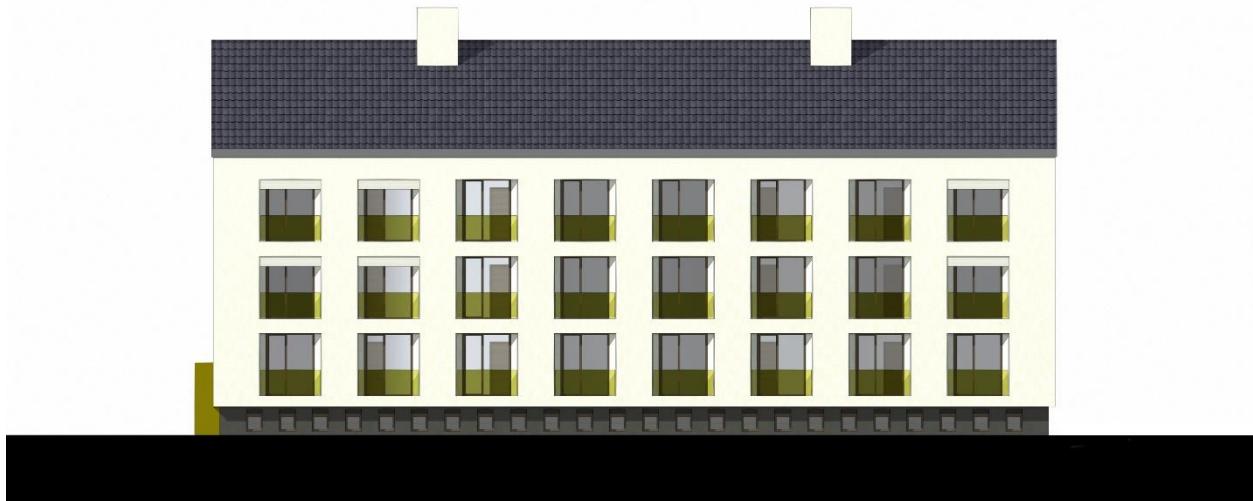
Figure 3.6a: Façade and roof design pilot building – alternative A

To be further developed, depends on the architectural design of the new product. Possible design alternatives go from the basic refurbishment up to large renovation with additional balcony, reading room installation and attic utilizing.

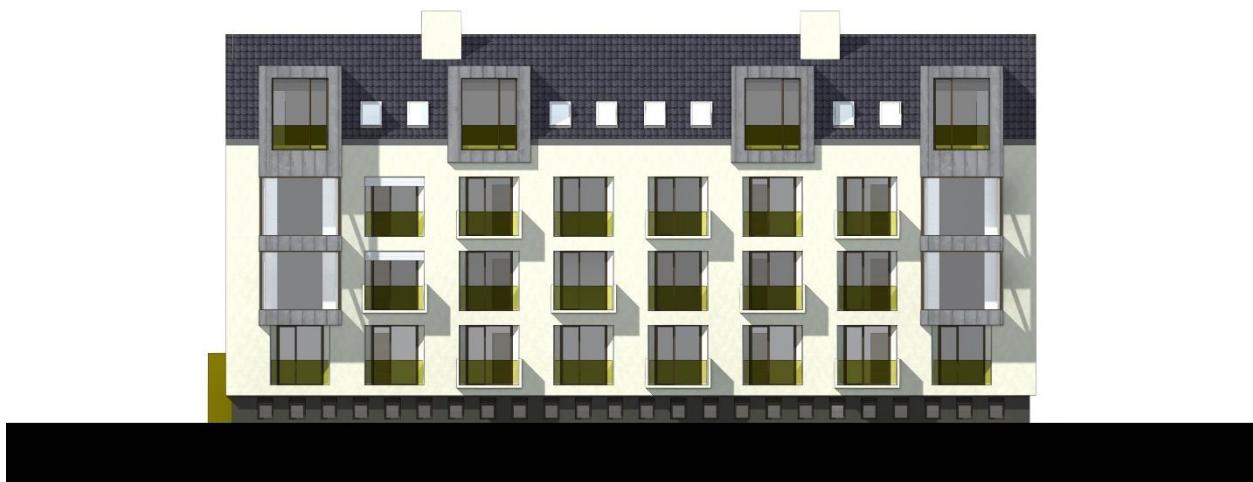
Figure 3.6b: Façade and roof design pilot building – alternative B

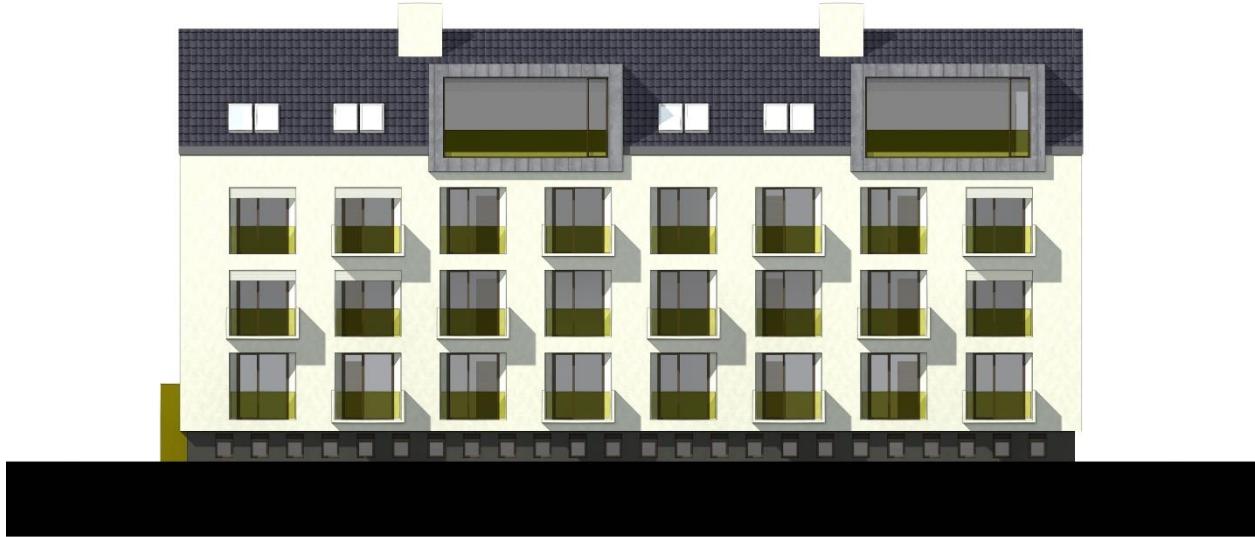
Figure 3.6c: Façade and roof design pilot building – alternative C

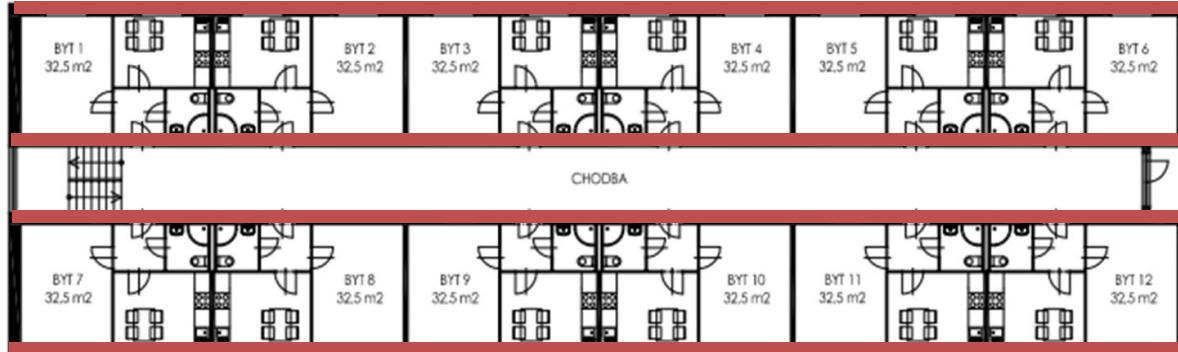
The constructional system present lateral masonry bearing walls.

Figure 3.7: Load bearing scheme pilot building

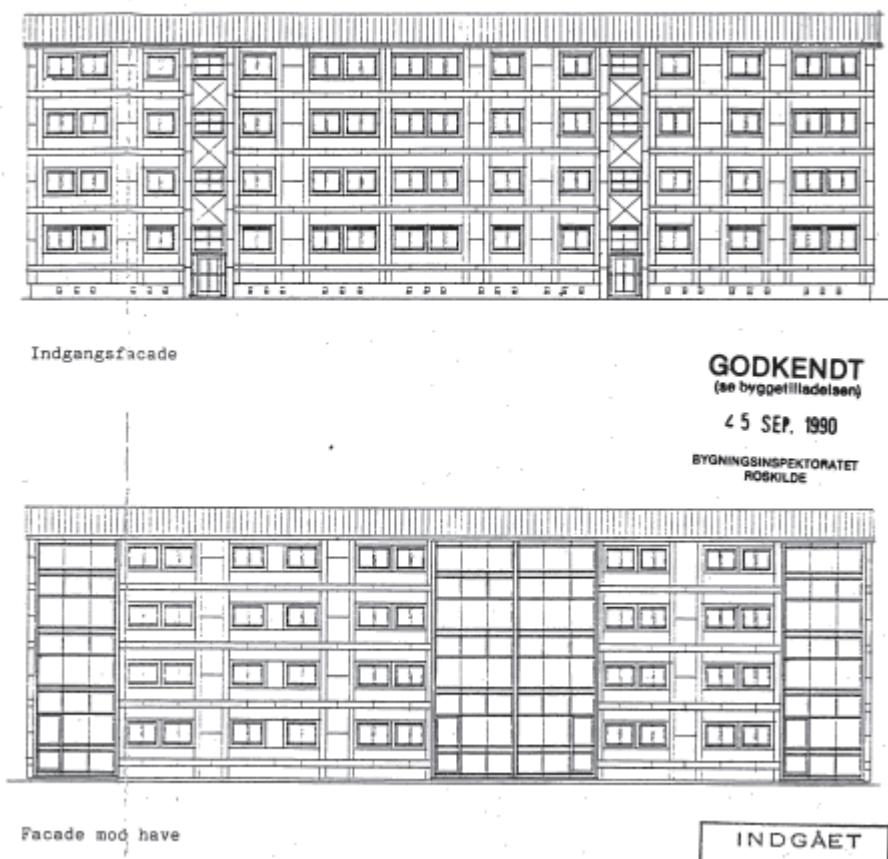
Figure 4.5: Façade and roof design pilot building

The building's façade and gable walls were renovated in 1991. As it appears from the drawings and photos they are plane with windows placed in a fixed pattern. The three buildings are placed with different angles of their longitudinal axes. The balconies were glazed when the facades were renovated.

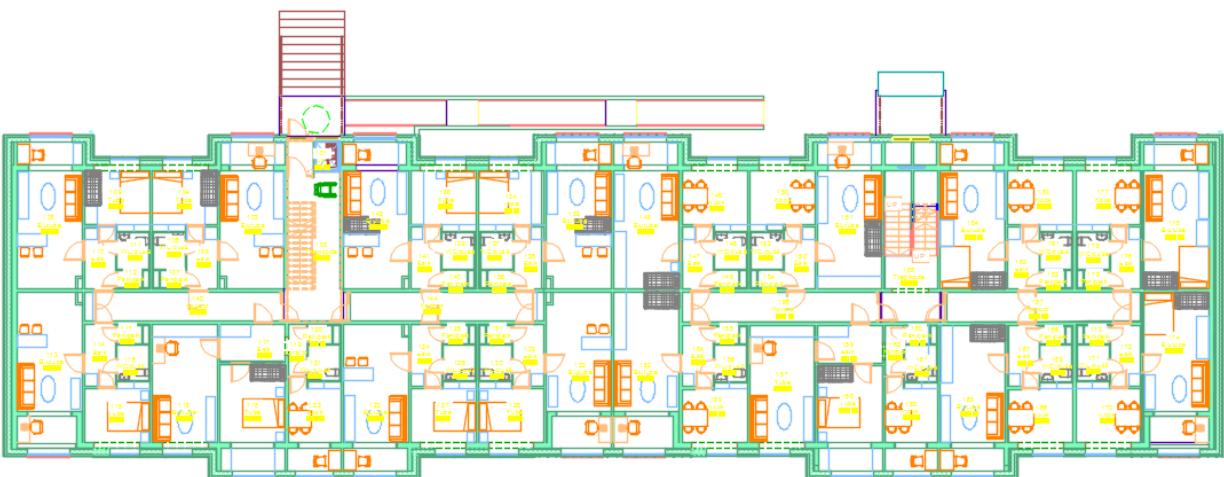
No major changes assumed in typical floor plan. Staircases will be re-formed in corridors and in front of the building in order to add the lift to one corridor. Open balconies on south and north longer walls will be closed with glazing.

Figure 5.4: Floor plan pilot building after renovation

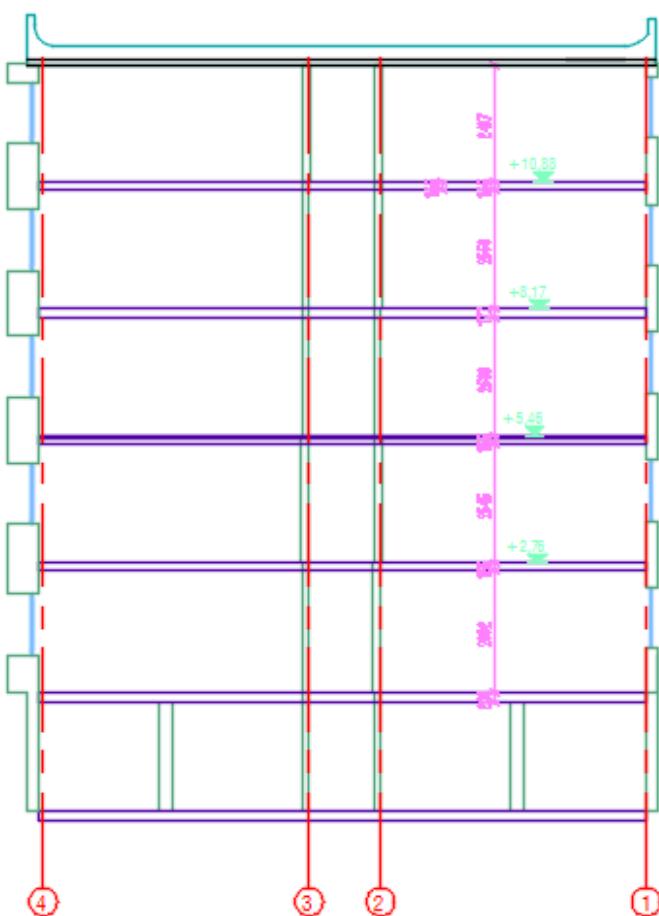
Figure 5.5: Cross section pilot building

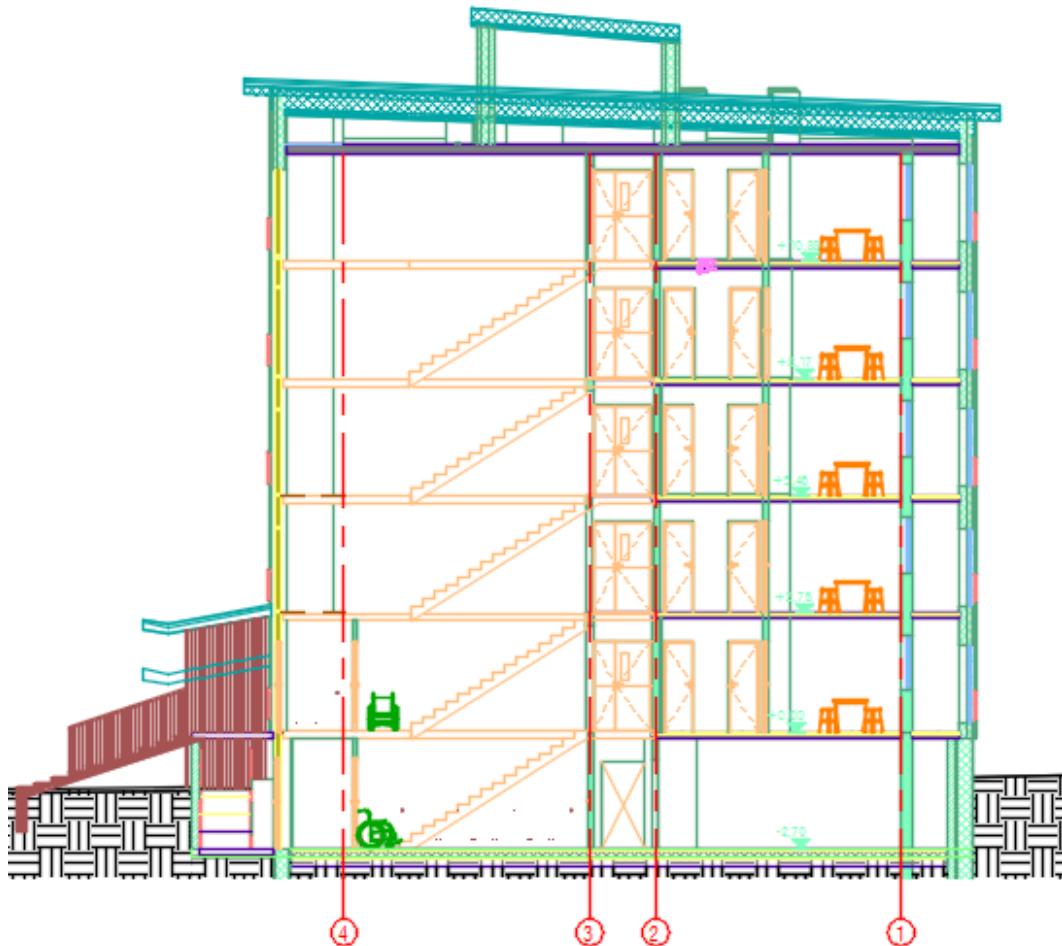
Roof will be made with sharper slope, wider edges and wind boxes. HVAC equipment will be placed into the container on roof.

Figure 5.6: Cross section pilot building after renovation

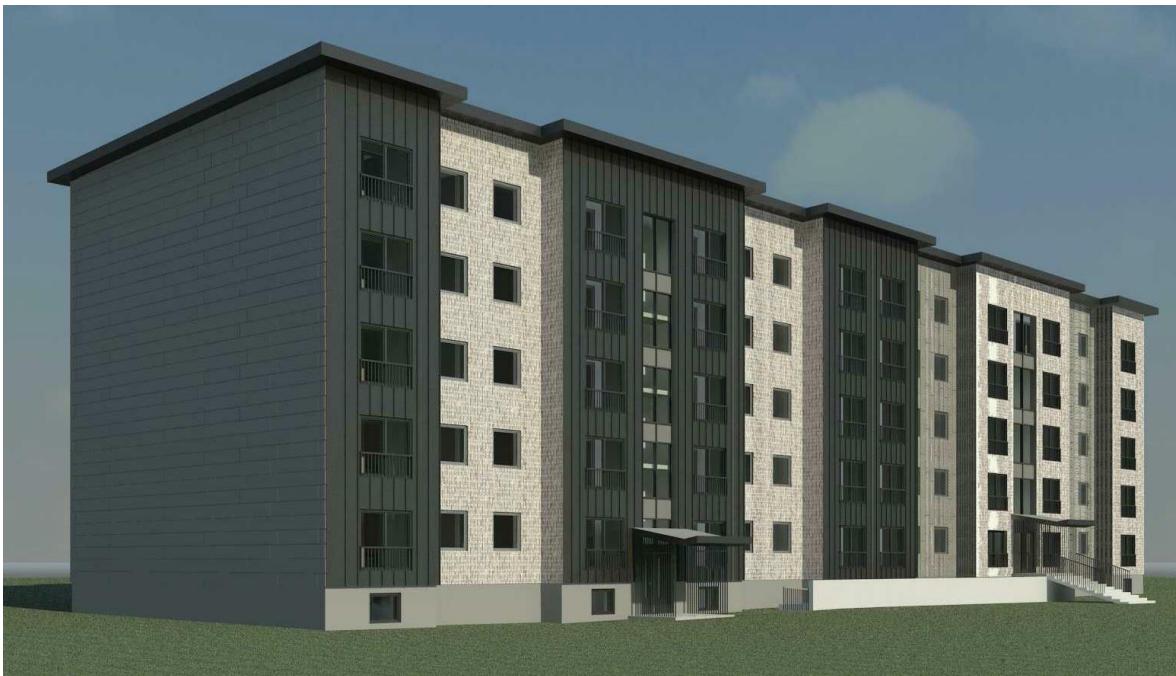
The architectural design depends on the facade panel's construction, weight and covering materials structure. The disposition of the panels with different colors will give a bright and fresh view to the whole building with wider and raised roof edges.

Figure 5.7: Façade and roof design pilot building after renovation

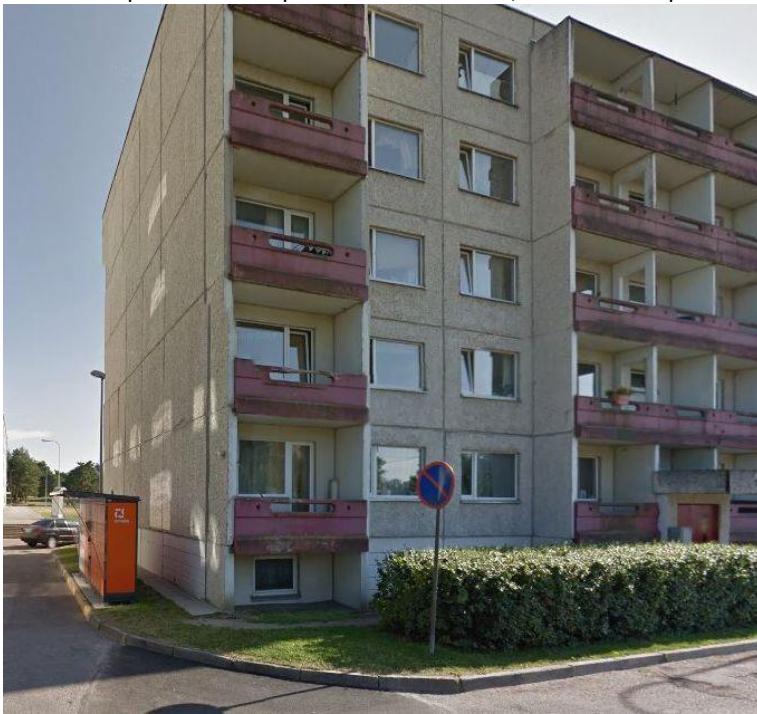
There are open balconies present in the facade, one in each apartment.

Figure 5.8: Complementary façade elements pilot building

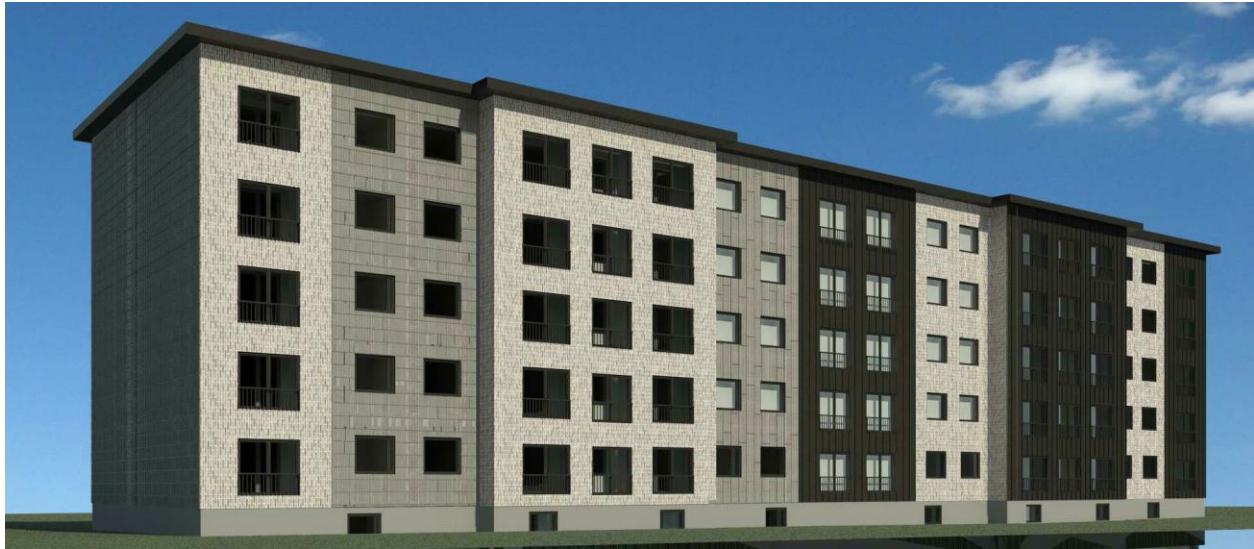
The balconies will be closed with glazing and thus will be as a part of living space.

Figure 5.9: Complementary façade elements pilot building after renovation

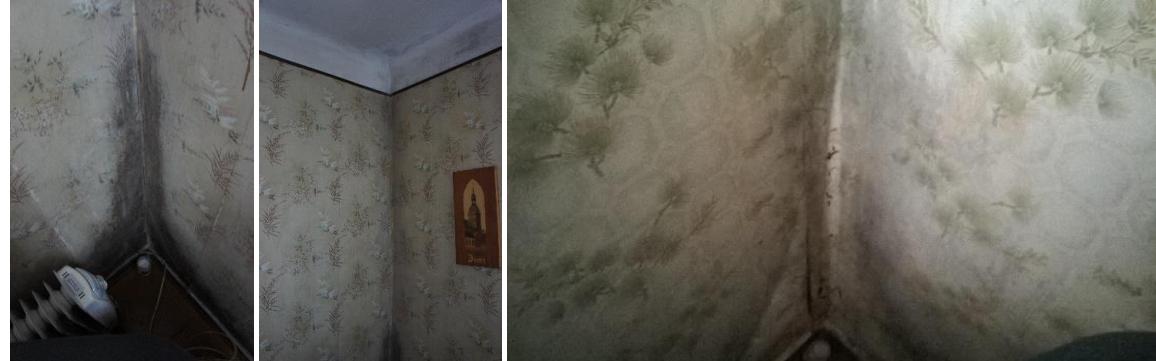
Mold growth on external corners.

Figure 6.1: Mold growth on external walls

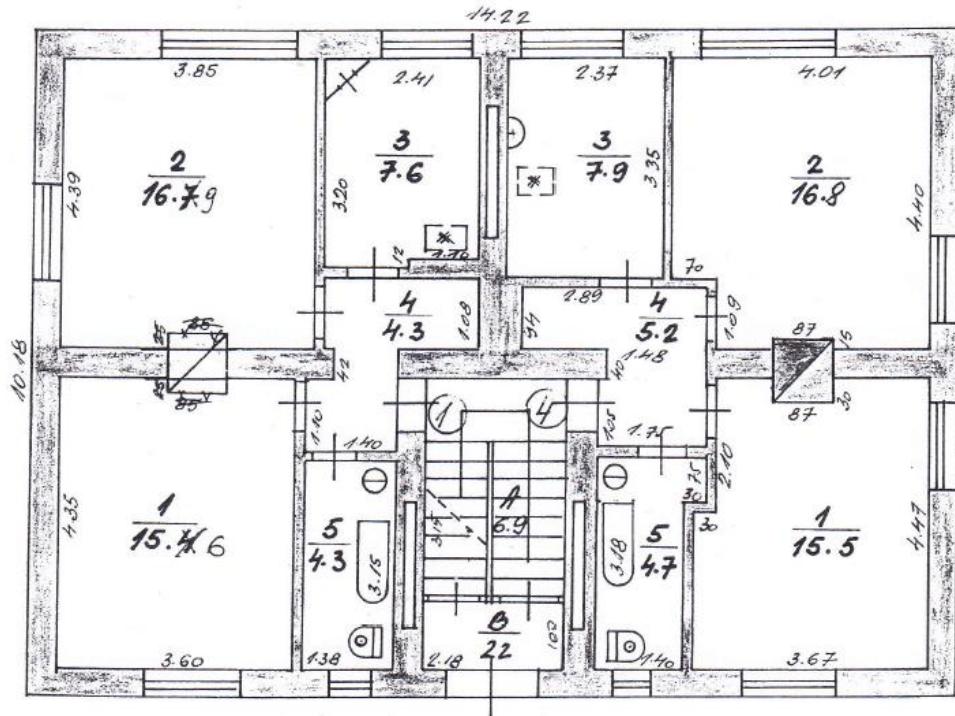
Figure 6.4: First floor plan

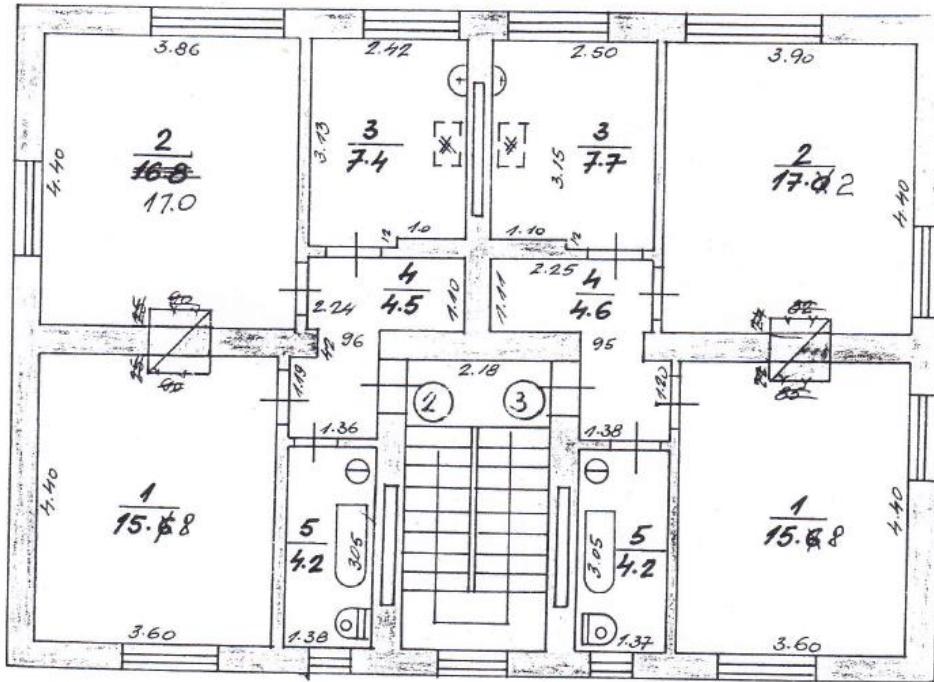
Figure 6.5: First floor plan

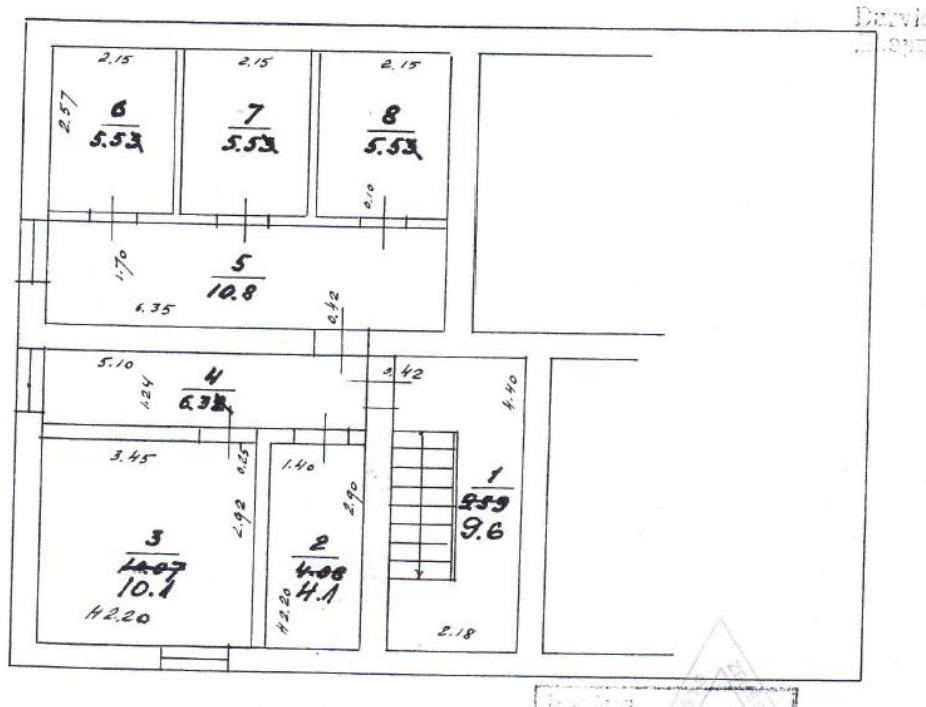
Figure 6.6: Basement floor plan

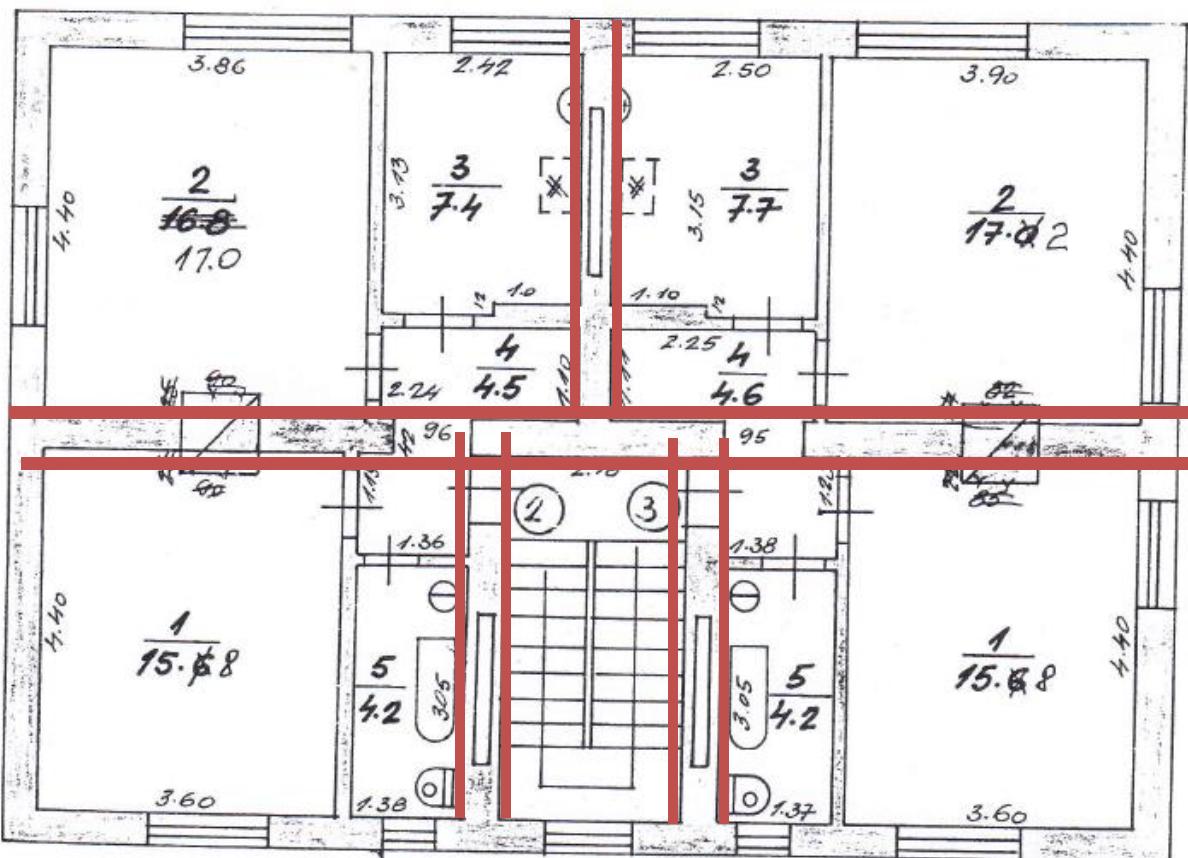
The constructional system present lateral masonry bearing walls.

Figure 6.7: Load-bearing scheme of pilot building

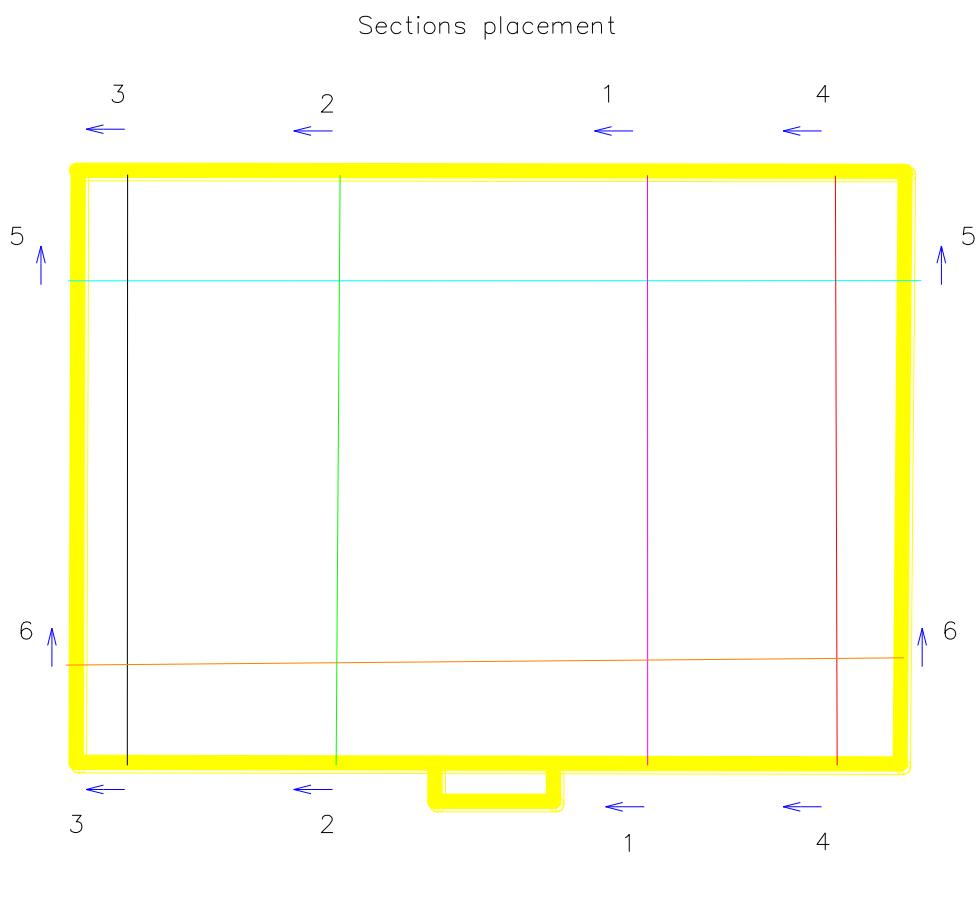
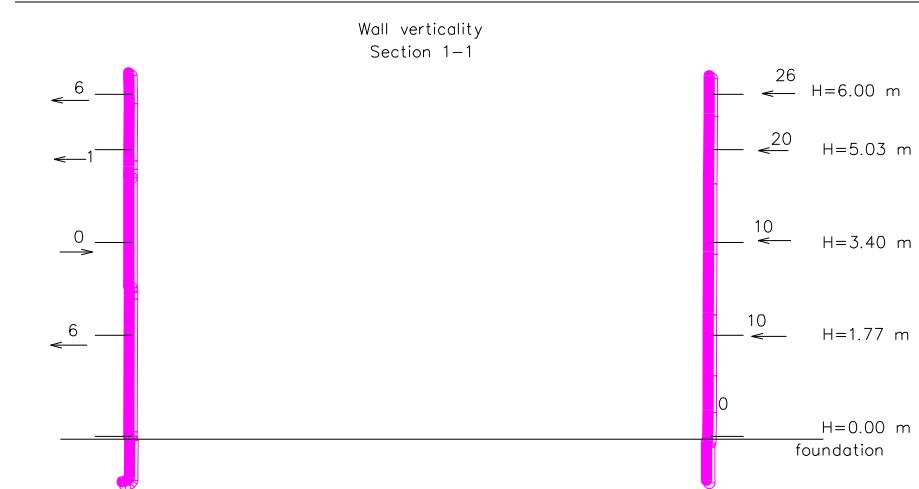
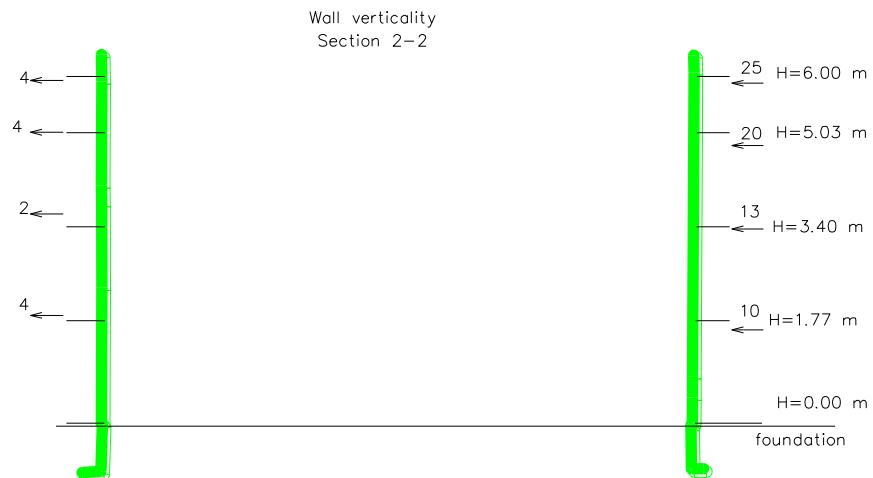
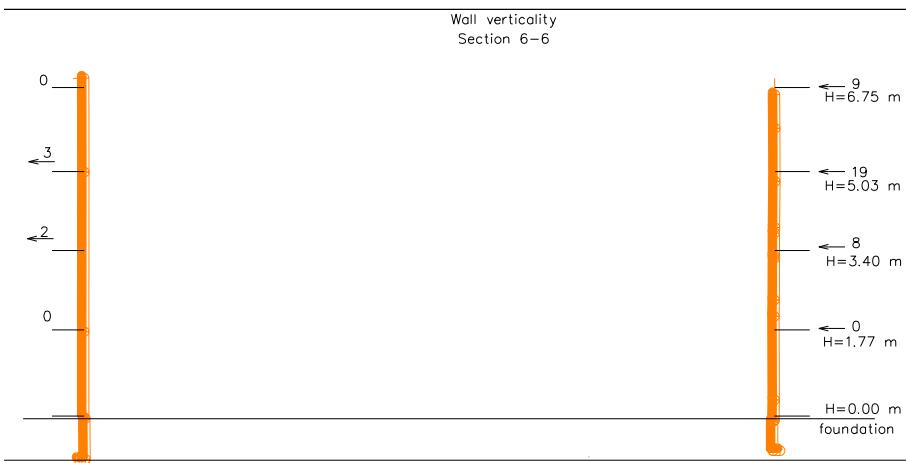
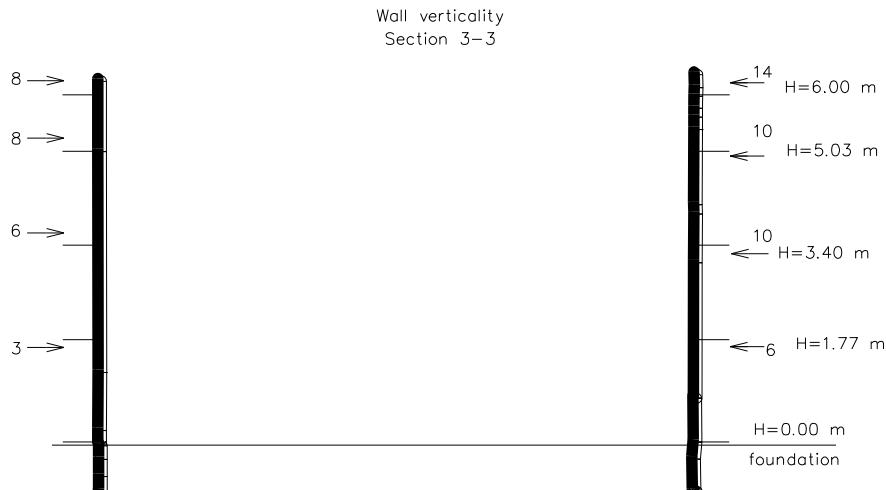
The vertical wall declination is shown in Figure 6.7

Figure 6.7: Vertical deviation of extremal walls

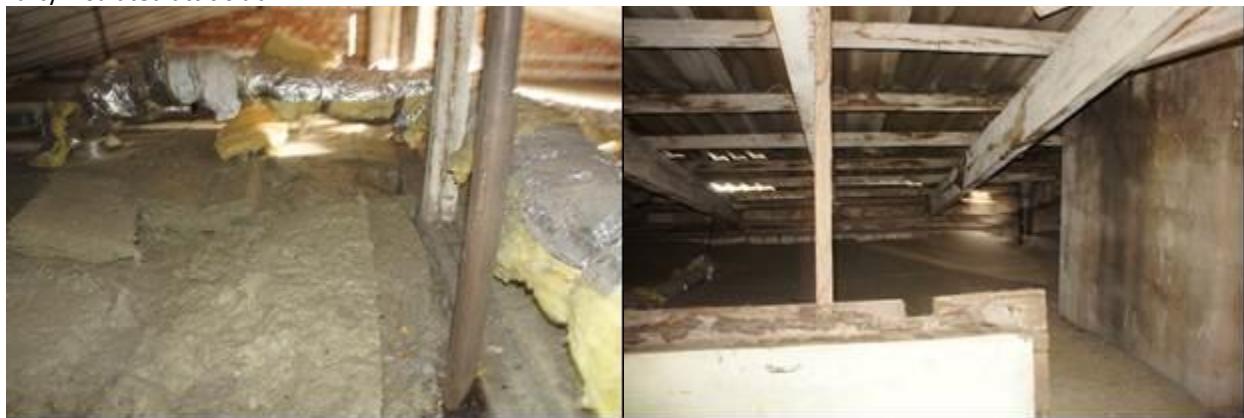
Party insulated attic slab.

Figure 6.8: Attic thermal insulation

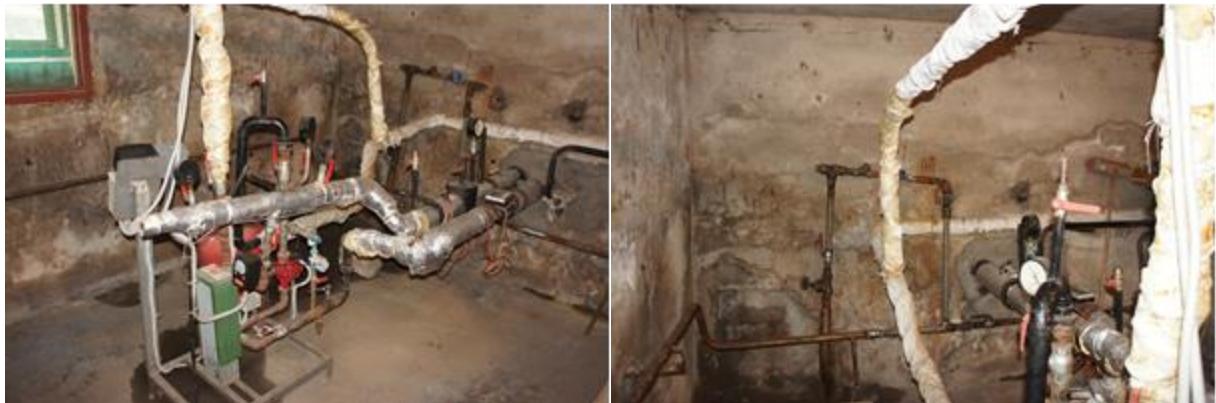
Building is connected to district heating system. Building has single pipe heating system.

Figure 6.9: Technical conditions of district heat substation

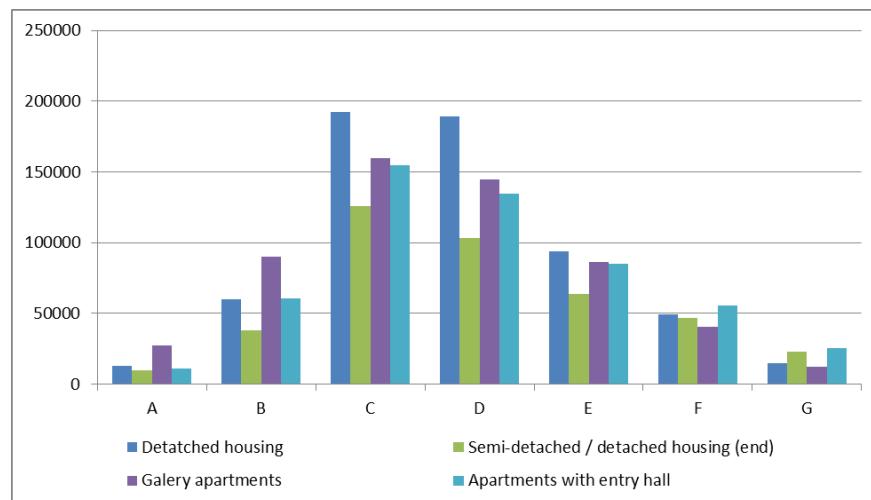
Energy labels classified according four housing typologies in the Dutch residential sector (adjusted from Senternovem, 2012).

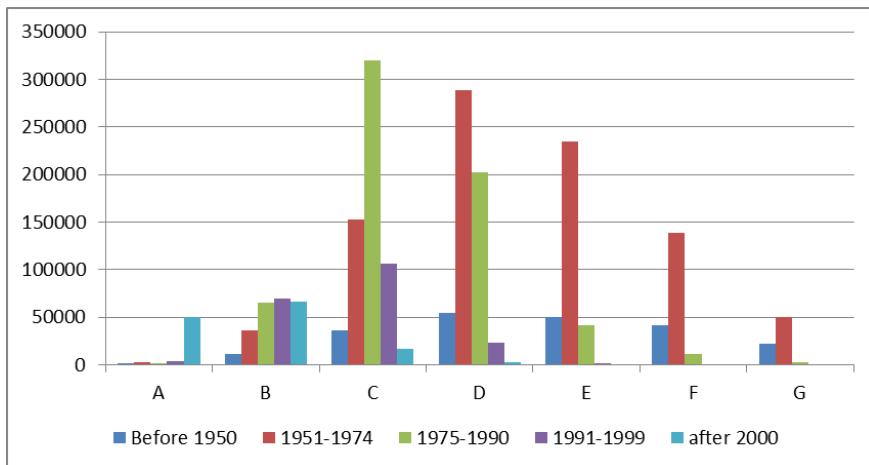
Energy labels of four housing typologies classified according year of construction. Dwellings constructed before 1975; 1991; 2000 are predominately labelled as respectively D-E; C-D; B-D. The peak among label A dwellings are the result of stricter building codes introduced in 2000, 2006 and 2012 respectively (energy performance indicator) (adjusted from SenterNovem, 2012).

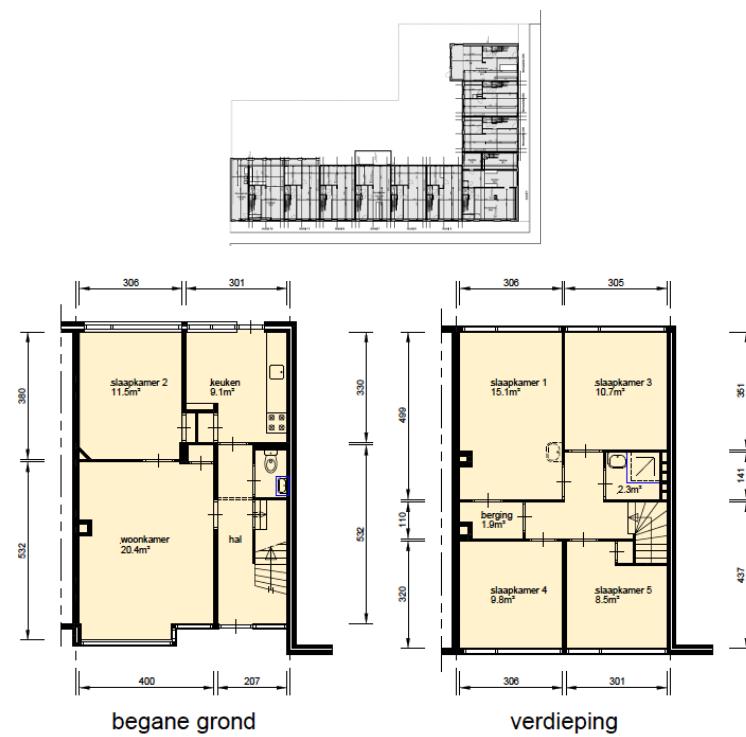
1. Typology reference building: Terraced house, block-by-block. NL – Kanaleneiland, Utrecht, Occupied by 10 families (10); one building block consisting of 10 dwellings (two stories, flat roof).

Construction period	1960 to 1975
Statistics	175.000
Year of construction reference building	1965
Previous nZEB investments	<i>Single glazing replaced by double glazing; improved heating system</i>
Number of housing units	10
Number of floors	2
Usable floor space (per unit)	+/- 120 m2

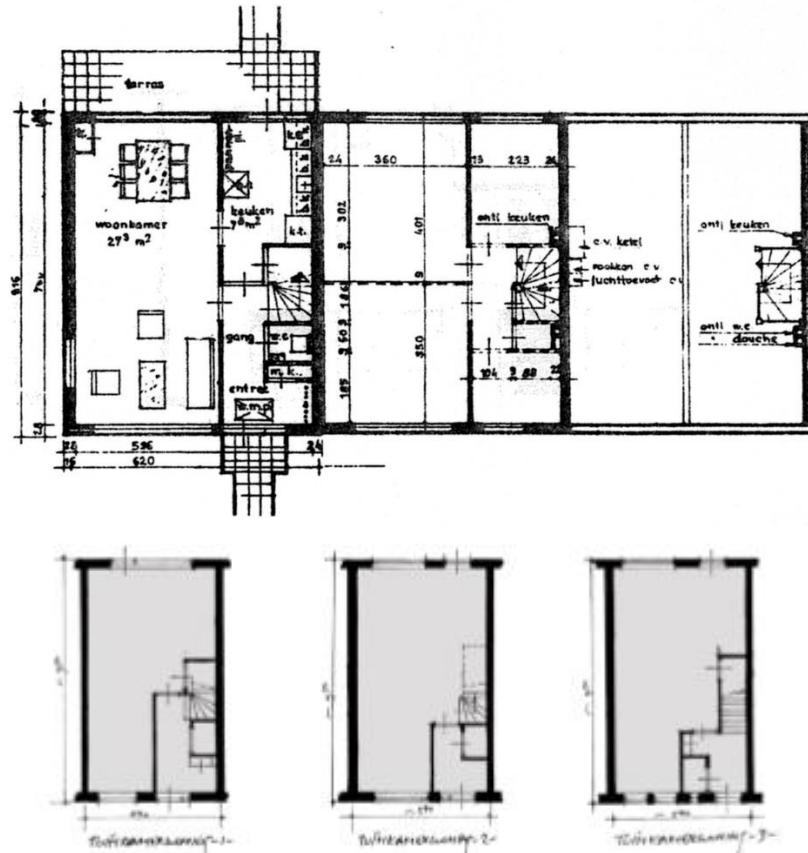
Since the sixties terraced housing in the Netherlands have been built based on the same lay-out with minor differences, see the schematics below representing the ground floor, first and second floor respectively. In most renovation projects the layout of the dwellings remain unchanged.

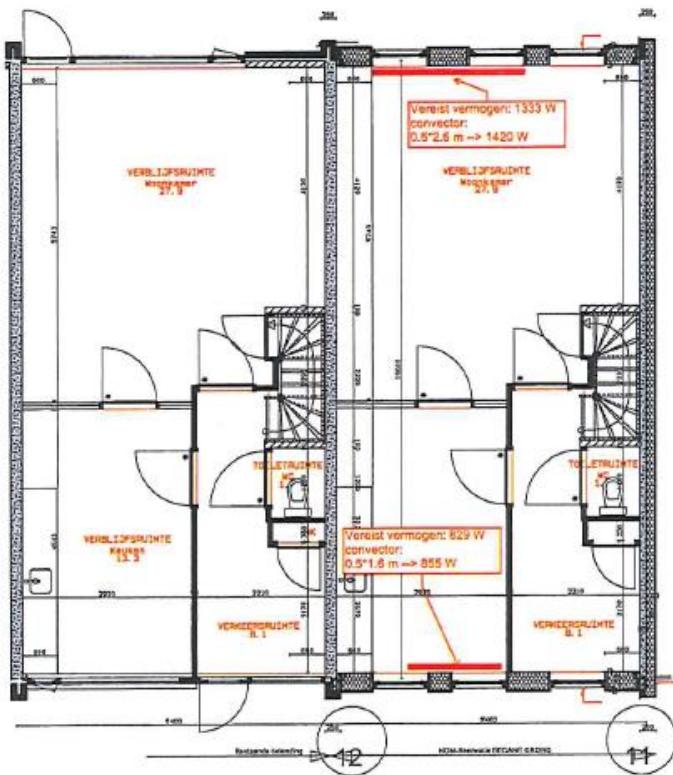
Ground floor, end-row dwelling (Oss, the Netherlands)

No significant changes assumed in typical floor plan for all 4 pilots. While all four projects have been retrofitted according the same principles only the floor plans of case project (3) have been included (Oss, the Netherlands).

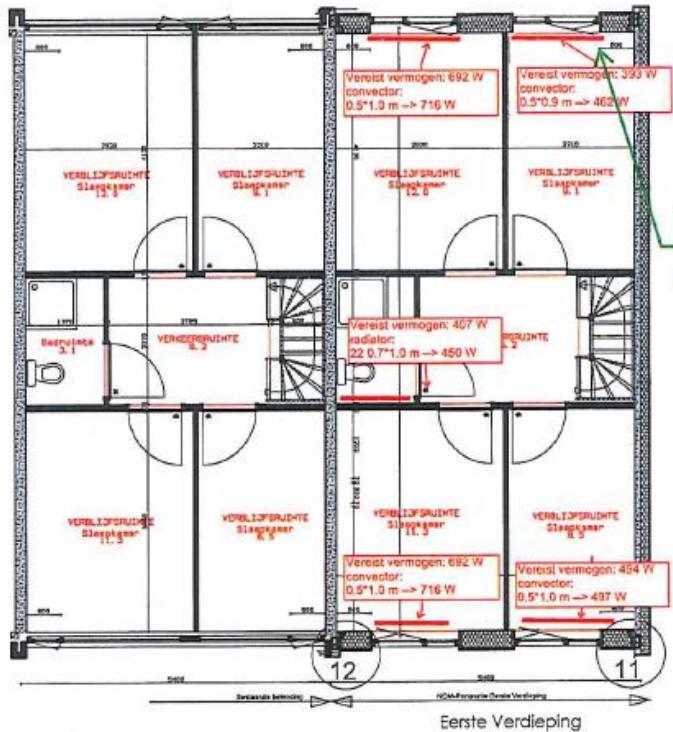
First floor, end-row dwelling (Oss, the Netherlands)

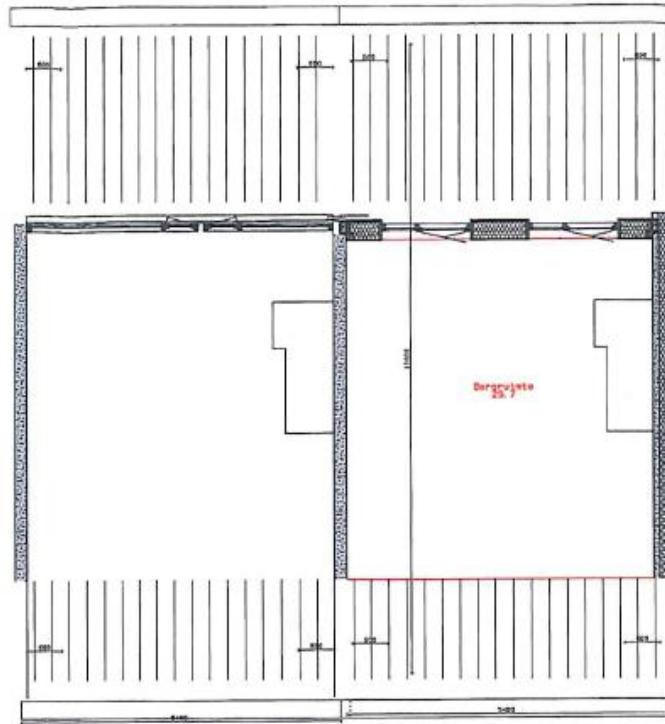
Second floor, end-row dwelling (Oss, the Netherlands)

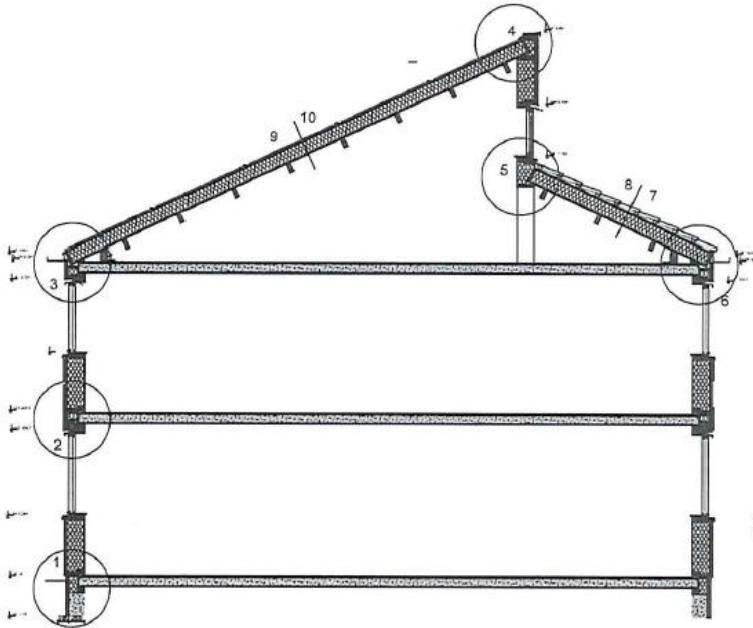
The masonry cavity walls (about 270mm) will be replaced by prefab façade elements which are much thicker (380mm, $R_c = 6,50 \text{ m}^2\text{K/W}$). Therefore, special attention needs to be devoted to minimize the loss of floor space.

Cross section, end-row dwelling (Oss, the Netherlands)
