Housing typology Assessment

MORE-CONNECT WP3.1, June 2016, J.A.W.H. van Oorschot, MSc., ed.

HOUSING TYPOLOGY ASSESSMENT
MORE-CONNECT WP3.1

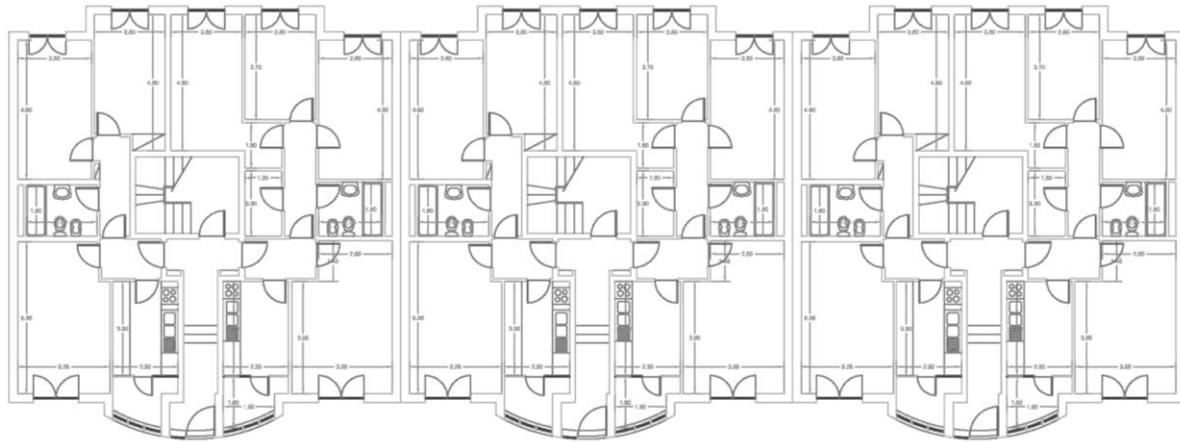
Figure 8.3a: First floor plan of the Portuguese pilot building

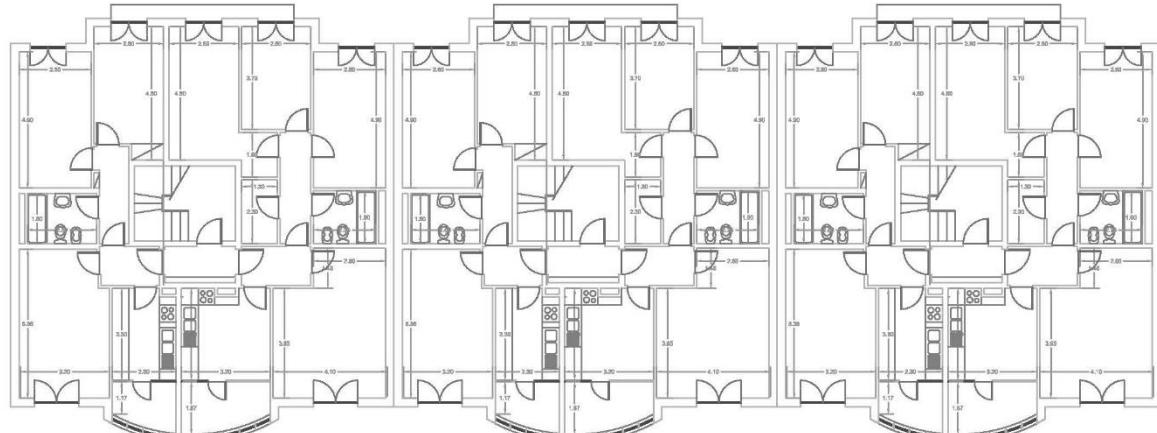
Figure 8.3b: Second and third floor plan of the Portuguese pilot building

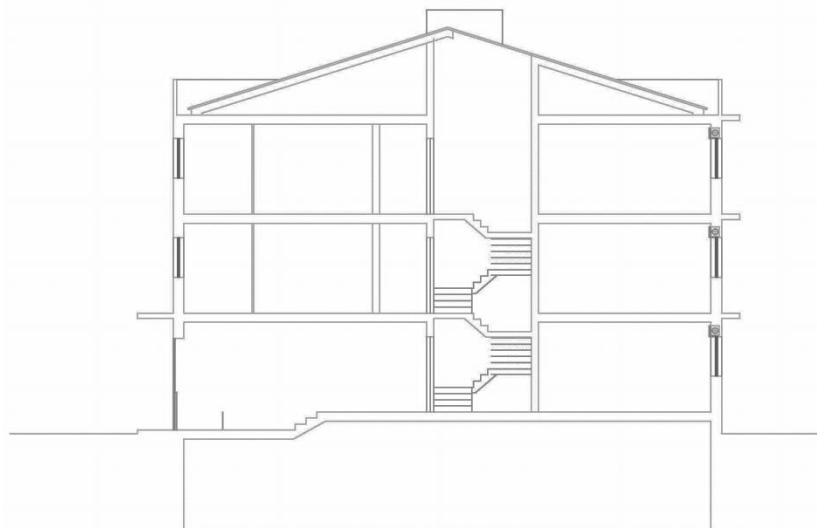
Figure 8.4b: Transversal section view of the Portuguese pilot building

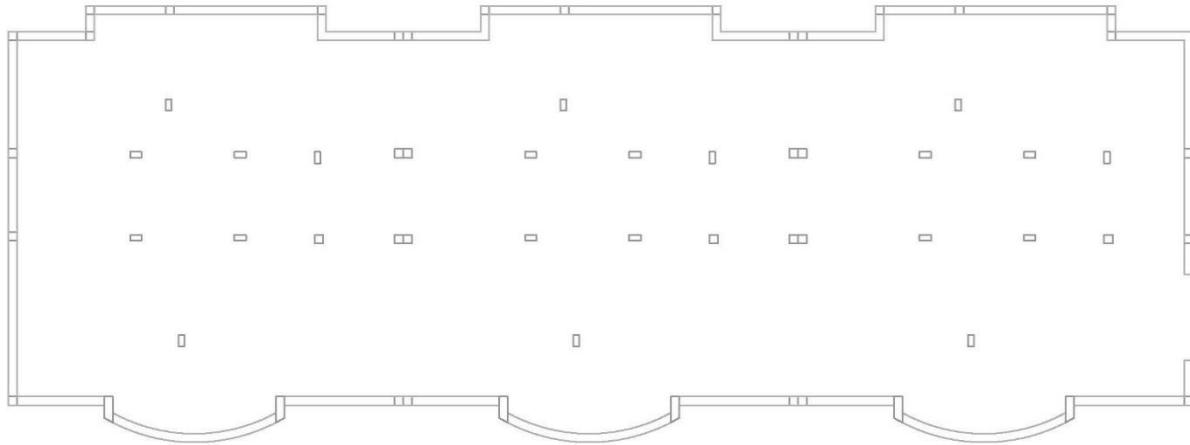
This building is composed by a pillars and beam structure with hollow brick masonry walls and beam and pot slabs.

Figure 8.6: Load bearing scheme of the Portuguese pilot building
